Leak History #46 | Masked Economizer Leak in a Recovery Mill

Problem: Tube Leak
Boiler: Recovery Boiler
Equipment: 30 Metalborne Waveguides

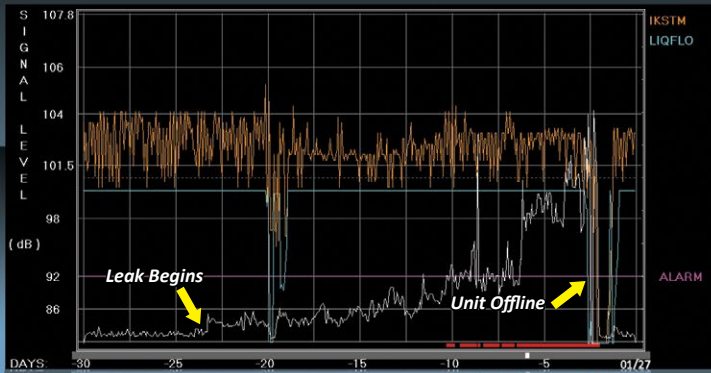
SENSOR 19, 30 DAY TREND

The acoustics for Sensor 19 first shifted from normal limits January 4. The increase was reported to the mill January 6, as part of the Surveillance Service. On January 20, the mill began to correlate possible operational changes driving the increasing acoustics, working in collaboration with the Acoustic Monitoring System (AMS) Surveillance team. The Chill and Blow (performed January 8) was eliminated as the driver of the acoustics at that time. The mill continued investigating and discovered two leaking sootblower valves. At that time, the mill was attributing the increased acoustics to the malfunctioning sootblower issue.

On January 24, at approximately 12:30, the mill and Surveillance Team worked together to isolate the sootblower system and analyze the acoustics. Acoustic levels across the system returned to normal limits with the exception of sensor 19. The signal showed an approximate

3dB decrease with the sootblowers isolated while showing increased energy in the typical tube leak Spectrum Energy Distribution bandwidths. With the new information in hand, the mill investigated the area in detail. At approximately 13:30, the mill discovered evidence of a tube leak. Soon after, management made the decision to bring the unit down for repairs in a controlled fashion.
