Case Study 75 - Bushing Degradation

Autotransformer, originally Westinghouse but repaired by GE in 1989. 138/69 kV, class OA/FA/FOA, 50/66/83/93 MVA, core form.

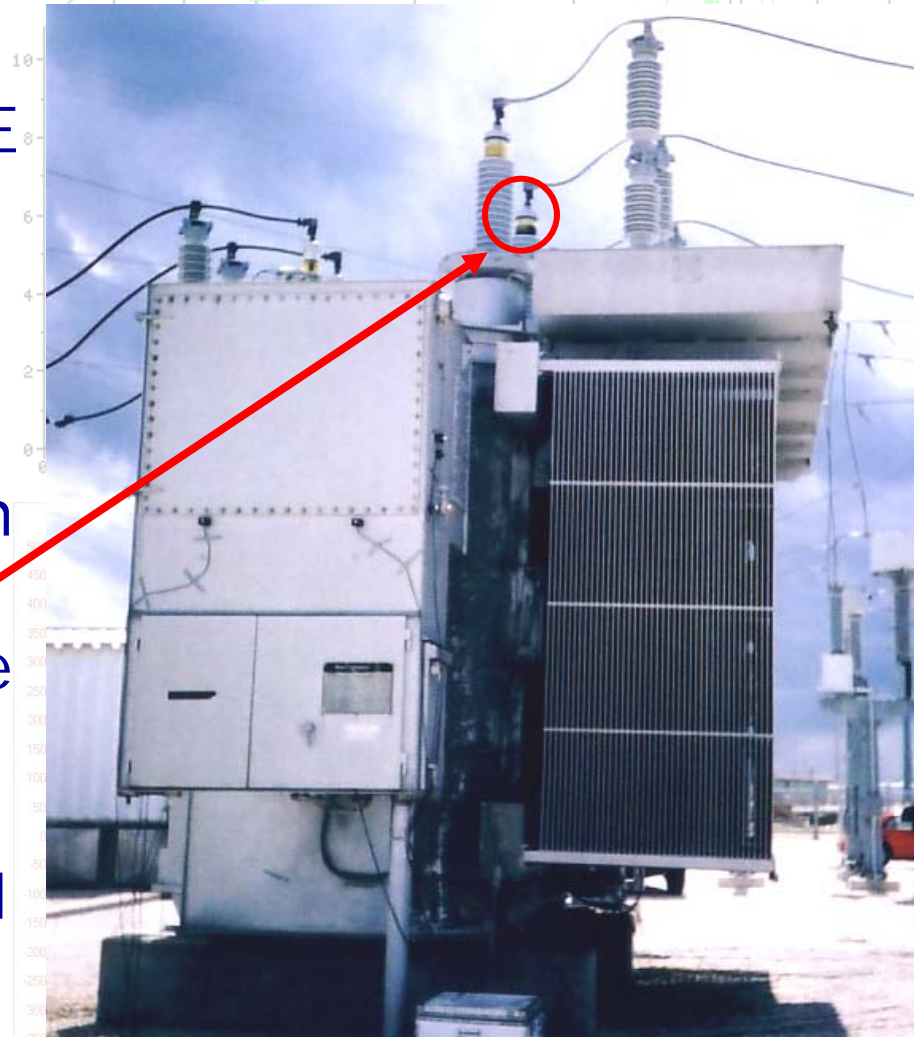
Oil on the upper part of the High Voltage bushing H2 was getting darker (looked like carbon in the oil).

HV Bushings Type O + C installed in March 2002

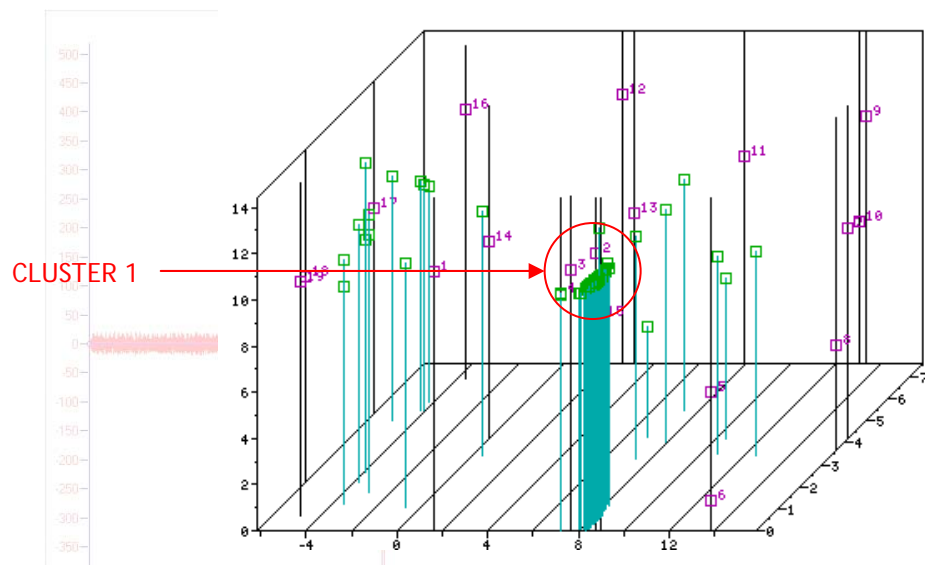
- AE Test performed in June 2003
- No acoustic activity was expected on the main tank because the gas in oil values indicate normal operation of the unit.

Cluster 1 was located a few inches from the high voltage (HV) wall, right in front of where the lower part of the H2 High Voltage bushing is located.
