Case Study 2062006

Transformer On-line monitoring

Physical Acoustics Corporation

CASE STUDY 2062006

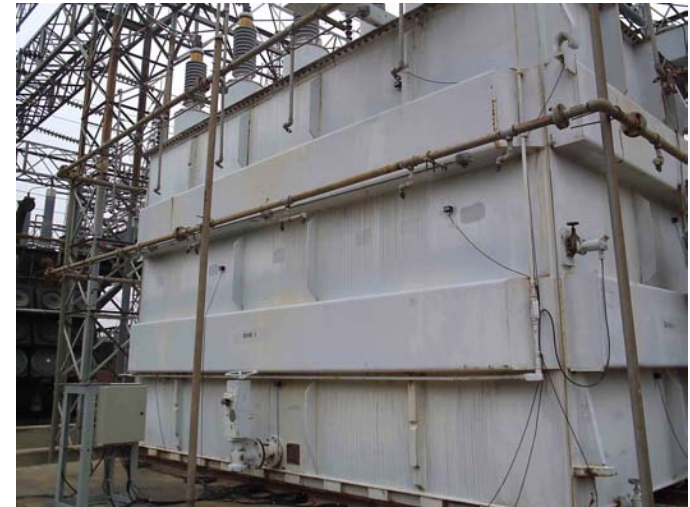
ON-LINE MONITORING

- On-line monitoring started in October 2006
- The same two areas of activity detected in June 2006 were detected during the entire monitoring period (Clusters 1 & 2).
- An on-line multiple combustible gases monitor was also installed
- No changes in TDCG were detected by the DGA monitor
- The two areas of acoustic activity corresponded to:
 - Middle section of Phase A coil
 - Upper part of Phase C coil
- The on-line system collected data from October 2006 – April 2007
