Case Study 75 - Bushing Degradation

Autotransformer, originally Westinghouse but repaired by GE in 1989. 138/69 kV, class OA/FA/FOA, 50/66/83/93 MVA, core form.

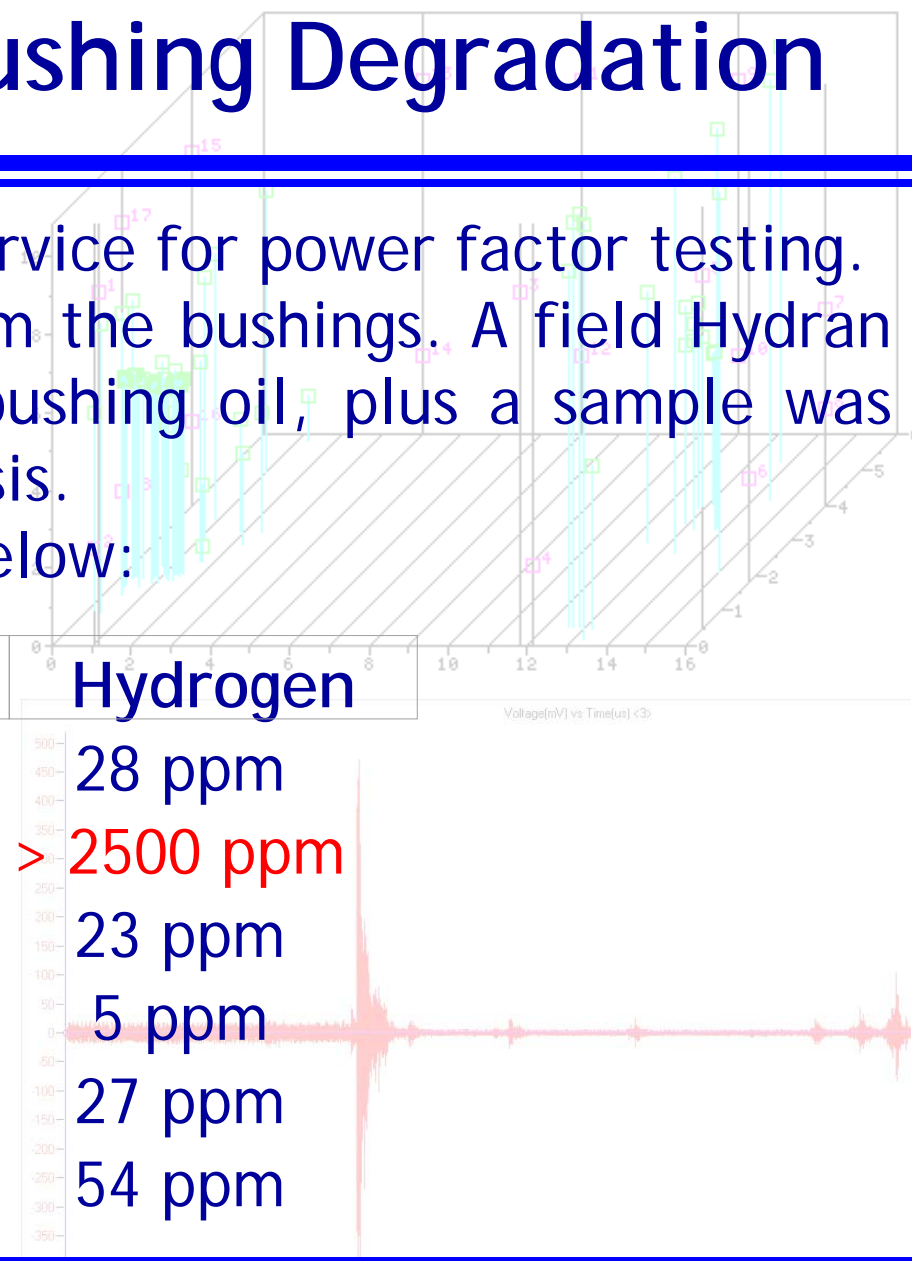
- Transformer removed from service for power factor testing.
- An oil sample was pulled from the bushings. A field Hydran test was performed on the bushing oil, plus a sample was sent to a laboratory for analysis.
- Results obtained are shown below:

> 2500 ppm

As can be seen, the laboratory turned up large amounts of gas on the H2 bushing. Most likely caused by PD activity.

This is the same bushing where the acoustic activity was detected on the main tank.
