Case Study 2062006

Transformer On-line monitoring

Physical Acoustics Corporation

CASE STUDY 2062006

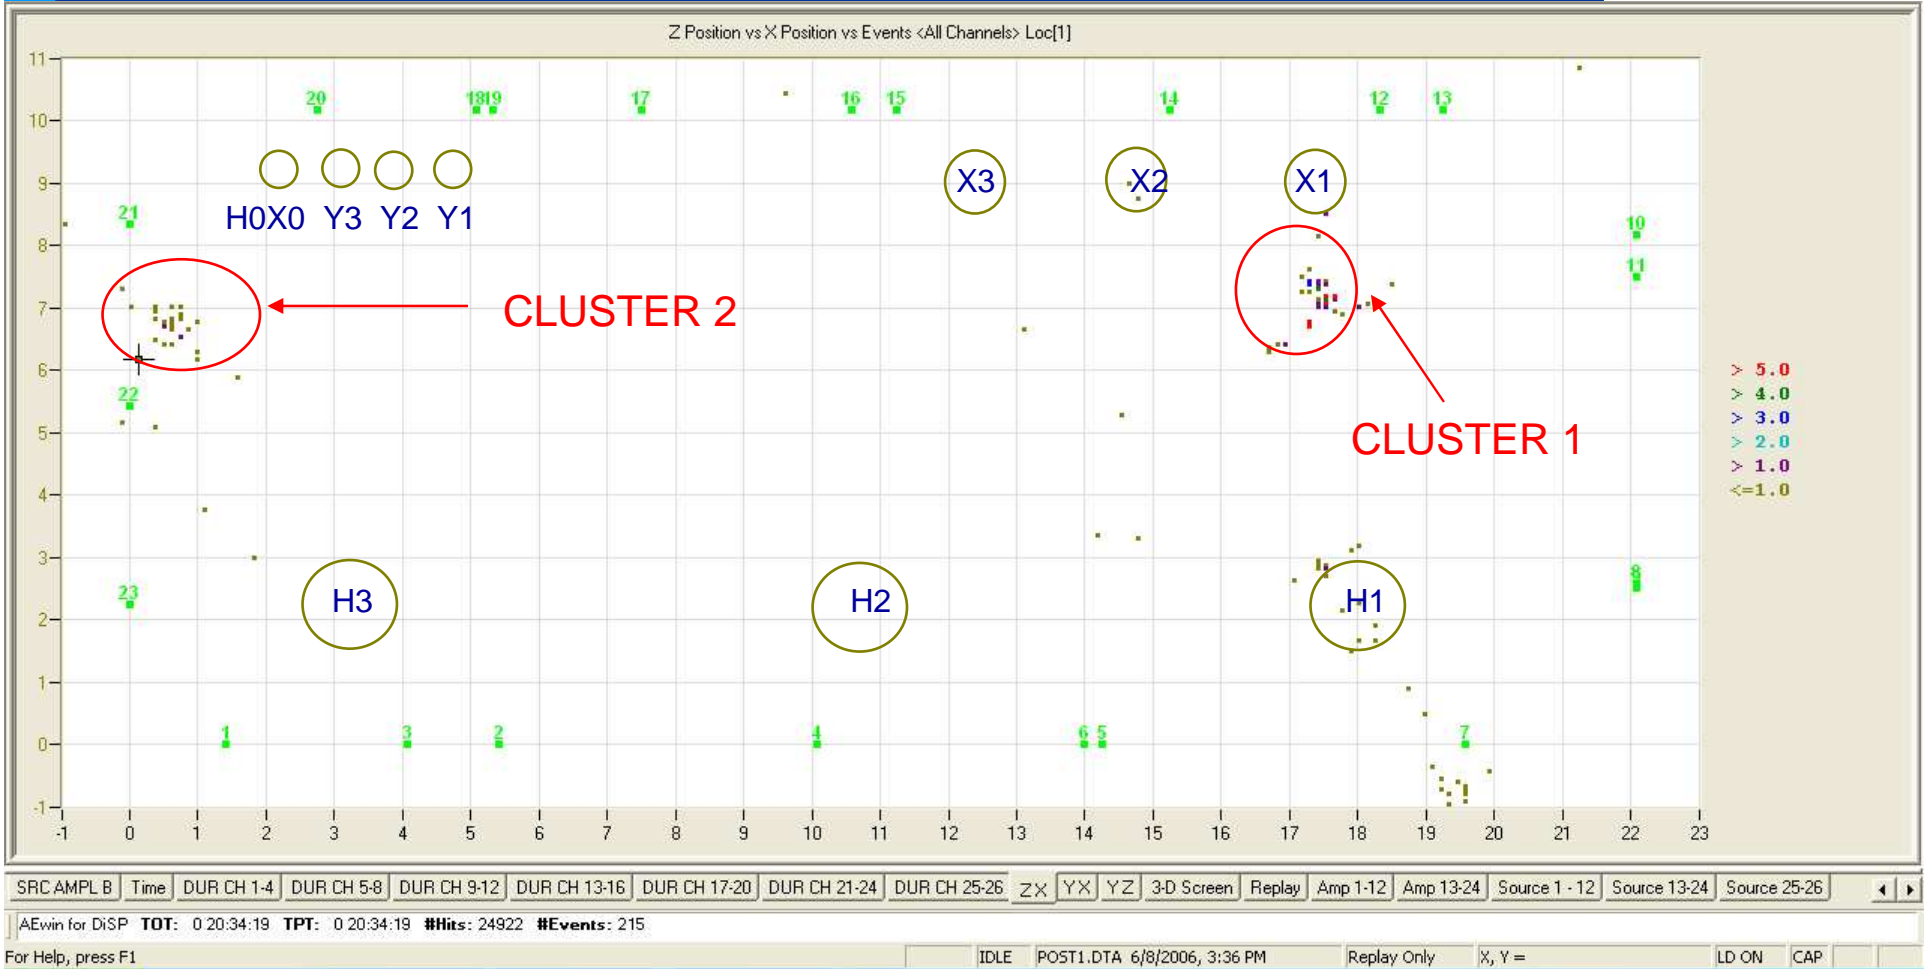
TOP VIEW

- On-line monitoring started in October 2006
- The same two areas of activity detected in June 2006 were detected during the entire monitoring period (Clusters 1 & 2).
- An on-line multiple combustible gases monitor was also installed
- No changes in TDCG were detected by the DGA monitor
- The two areas of acoustic activity corresponded to:
 - Middle section of Phase A coil
 - Upper part of Phase C coil
- The on-line system collected data from October 2006 – April 2007

1. The general vicinity of the H3/X3/Y3 winding assembly was noted as being considerably littered with dark/carbonaceous paper.
2. This unit by design incorporates the direct flow cooling system; speculation is that this material most likely originated from the inner layers of this winding assembly with the oil flow providing the vehicle for spreading this debris.

3. There is also considerable coverage of copper particulate in and around the top of this winding. This material ranges in size from "dust" to pieces similar in stature to that of a "pinhead" with a small percentage of larger "BB" size pieces found.
